# **Example Root Cause Analysis Report**

## **TRANSMITTAL OF INCIDENT INVESTIGATION REPORT**

# Investigation of the Acrylic Kettle (X-10) Incident on December 7, 1999

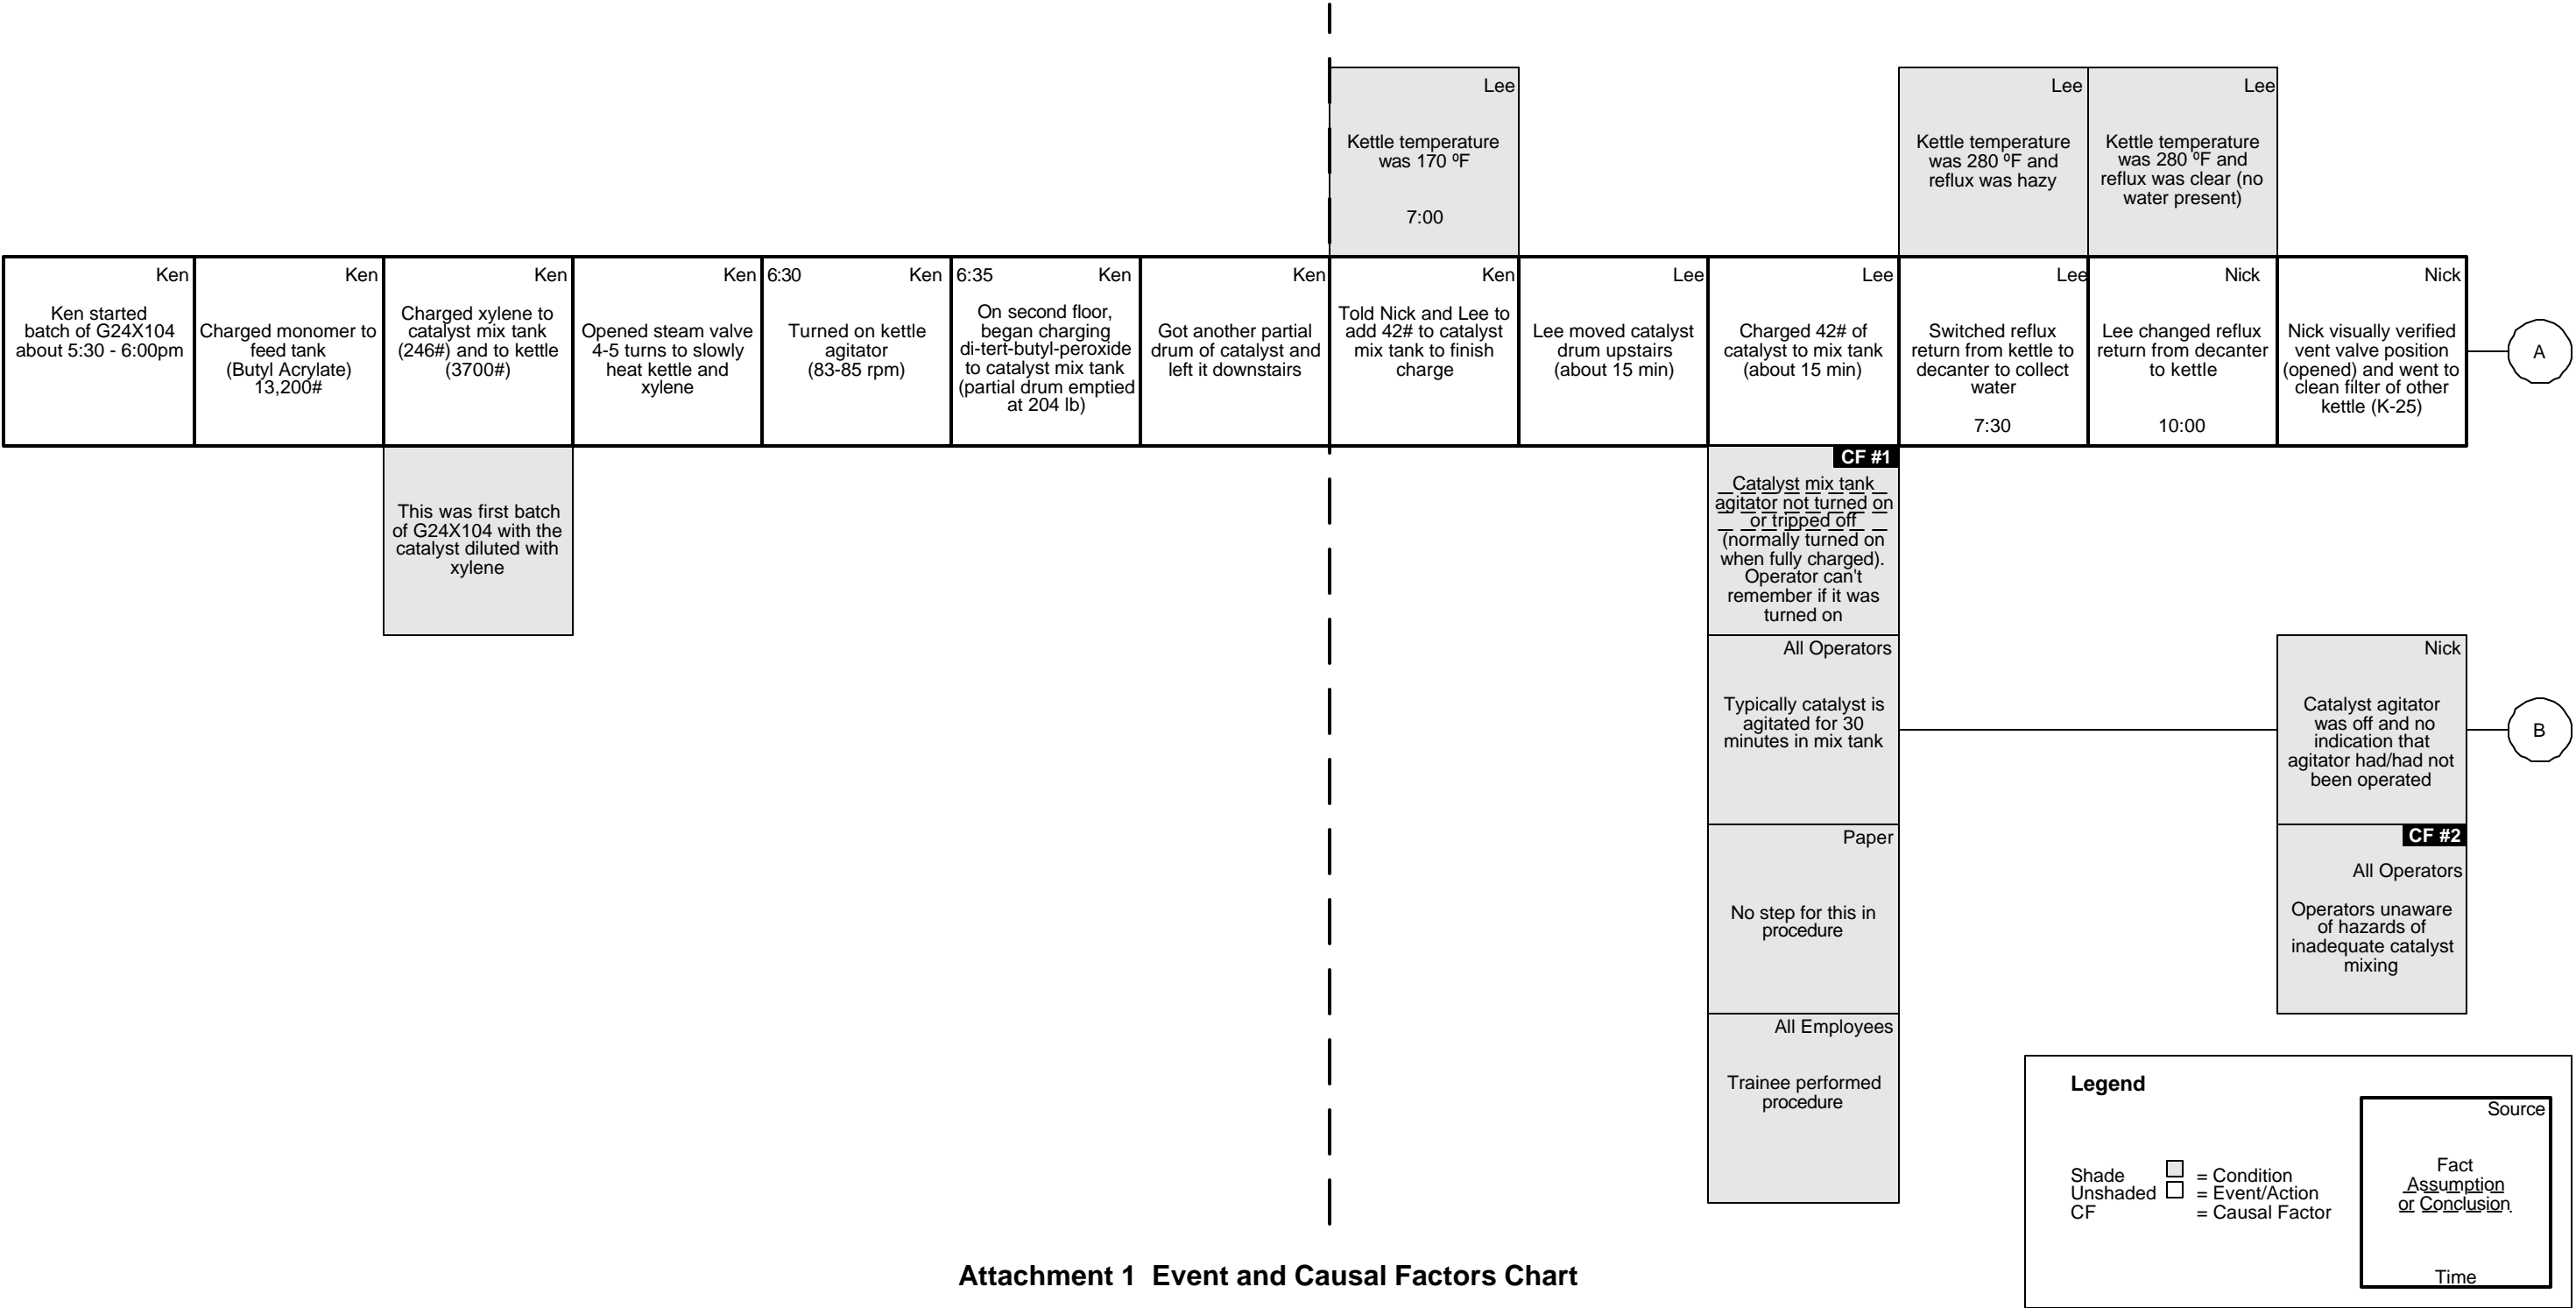
Attachment 1 Event and Causal Factors Chart

The data collected were then summarized in an Event and Causal Factors Chart (Attachment 1). This chart was used to help the investigators decide in what areas more data were necessary, and it also helps to clearly depict the relationship of key events related to the incident.
